September 24, 2023

SUBJECT: Construction Observation Report and Flood Flow Monitoring  
Temporary Gate Installation Project: Ashuelot Pond Dam: D245005  
Washington, NH 03280

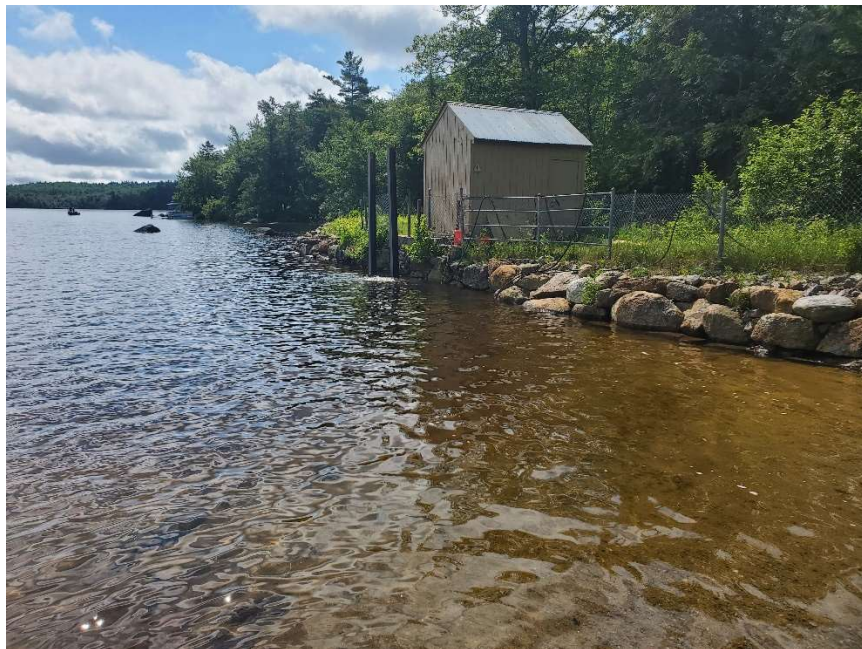
*Photo 1 – M&K Divers onsite June 21, 2023 completing additional concrete work at LLO*

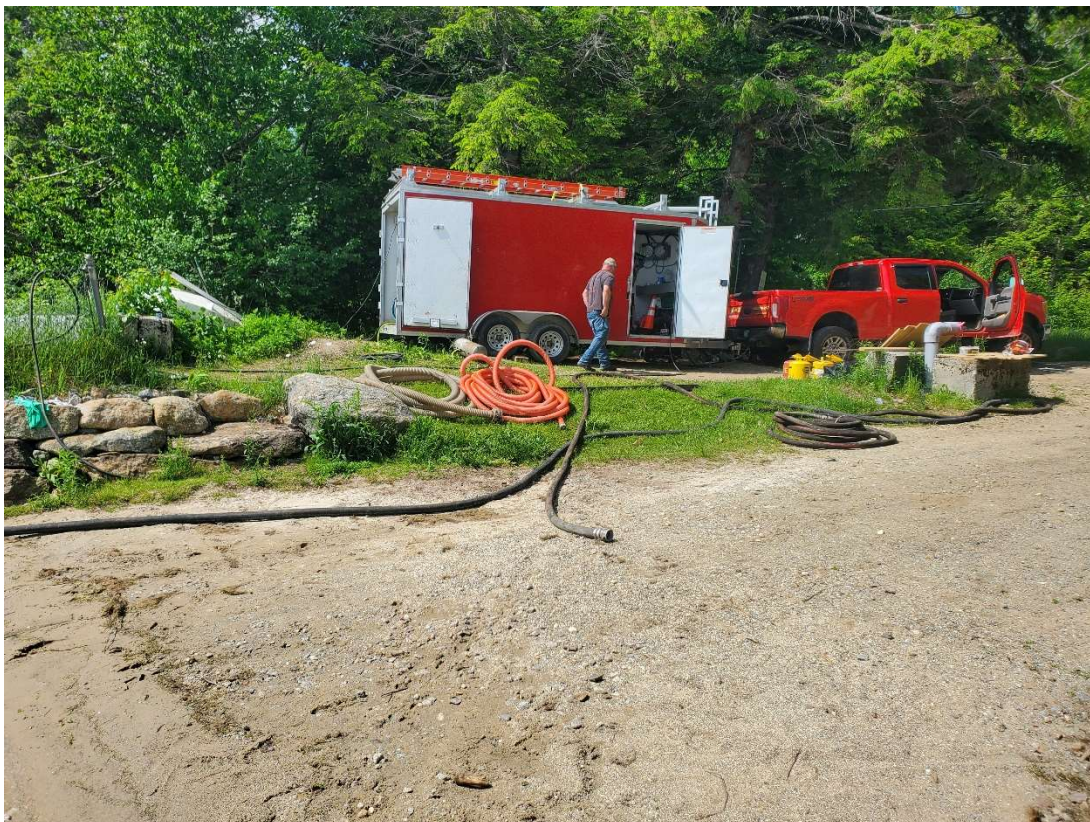
*Photo 2 – M&K setting up dive crew control trailer June 21, 2023*

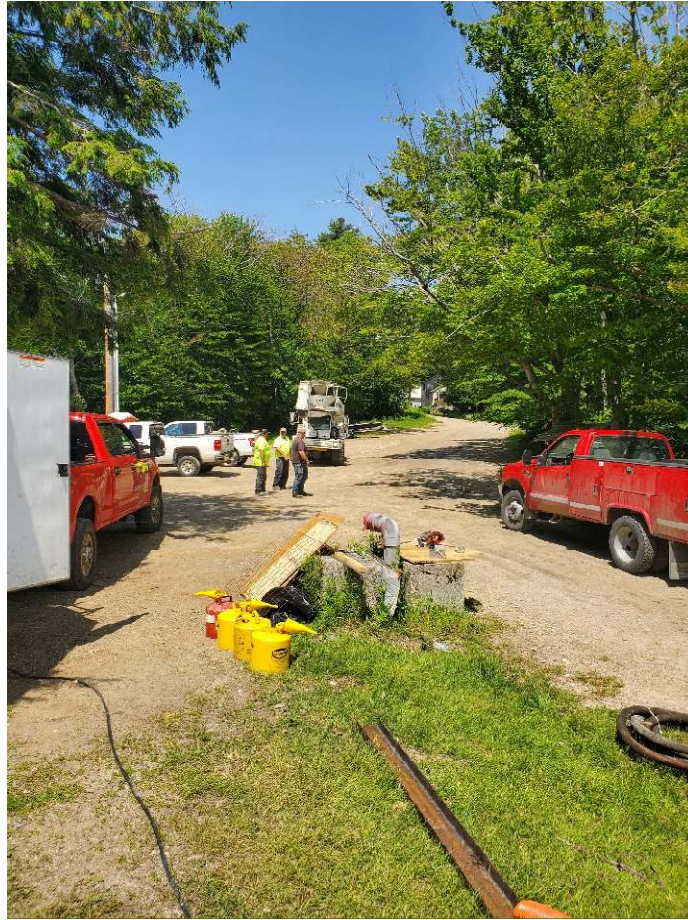
*Photo 3 –Carroll Concrete truck # 350 onsite June 21, 2023 with QA/QC representative onsite*

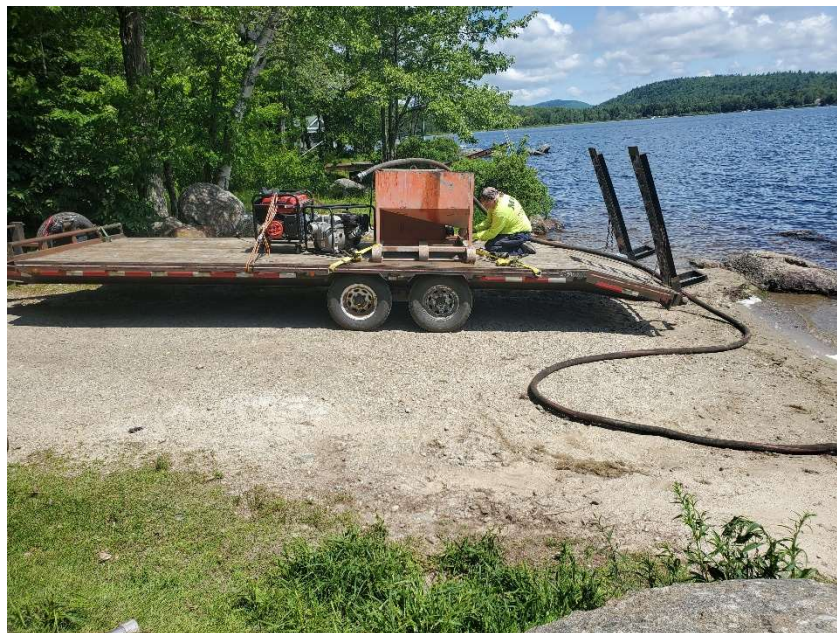
*Photo 4 – M&K pump onsite being prepared for final placement*

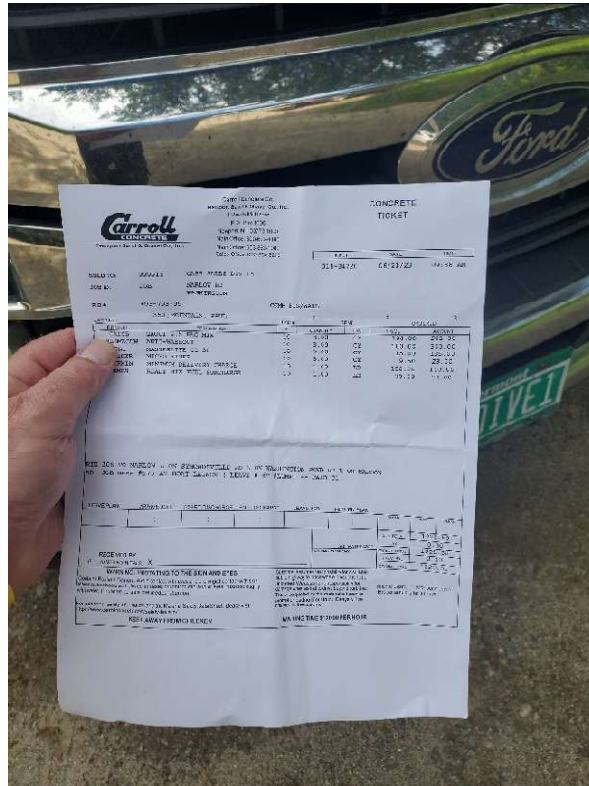
Photo 5 – Truck slip from final concrete pour

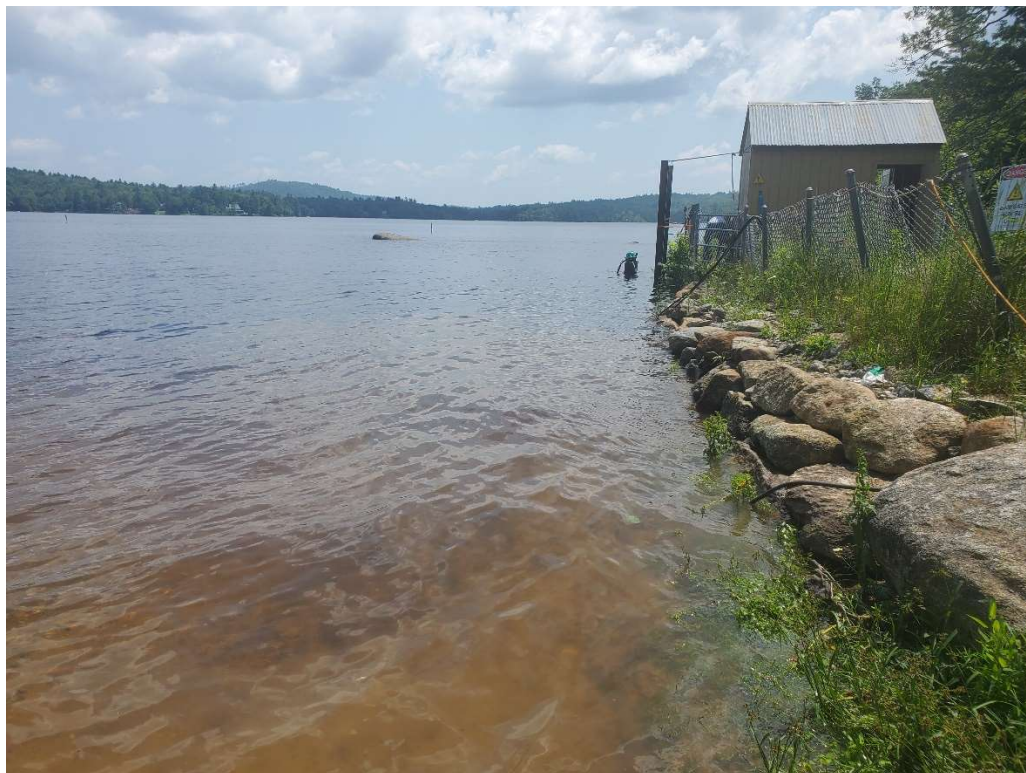
Photo 6 – High Water Observation – July 5, 2023 – note M&K Diver onsite – water level near the dam crest elevation

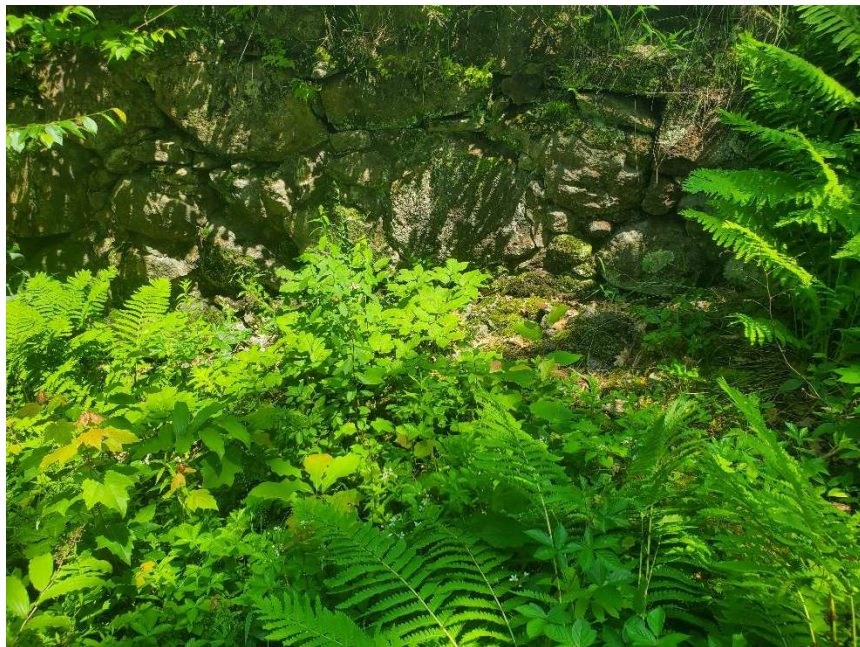
*Photo 7 – No observed seepage at downstream toe of dam during high water event July 5, 2023*

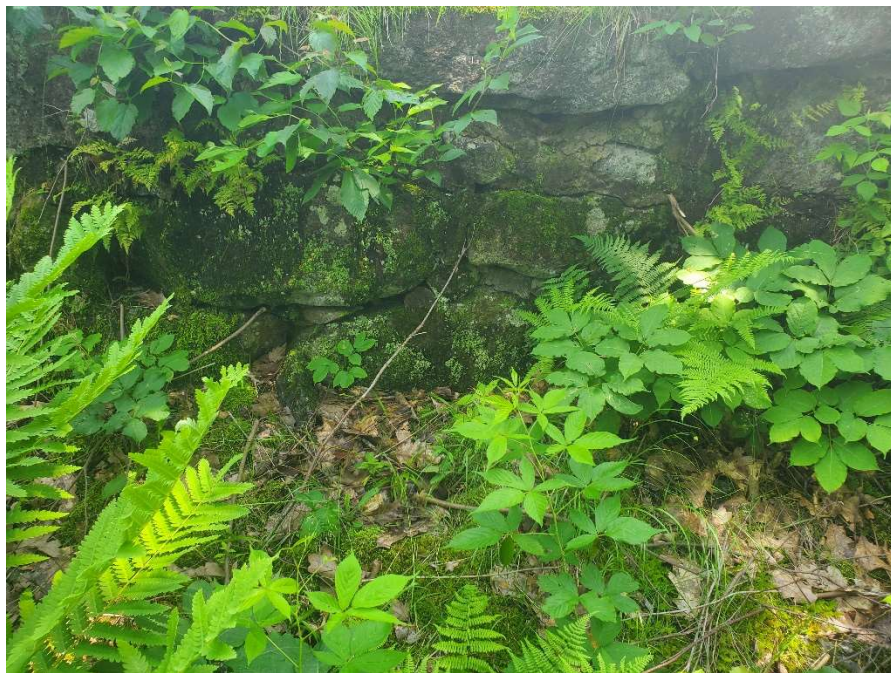
*Photo 8 – No observed seepage at downstream toe of dam during high water event July 5, 2023*

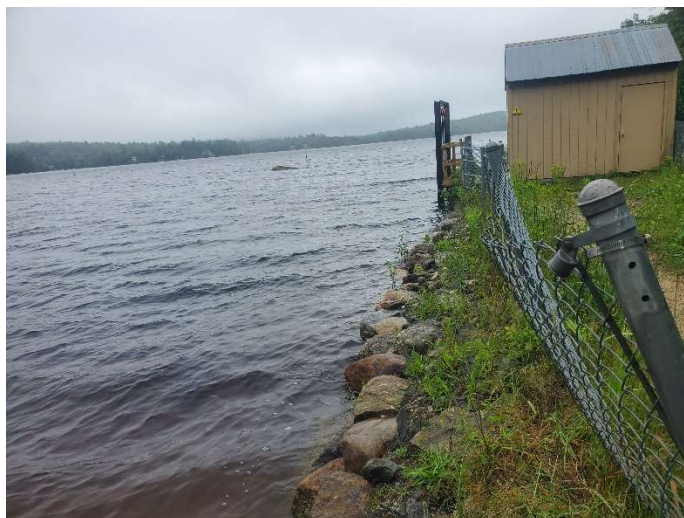
*Photo 9 – High water event July 10, 2023*

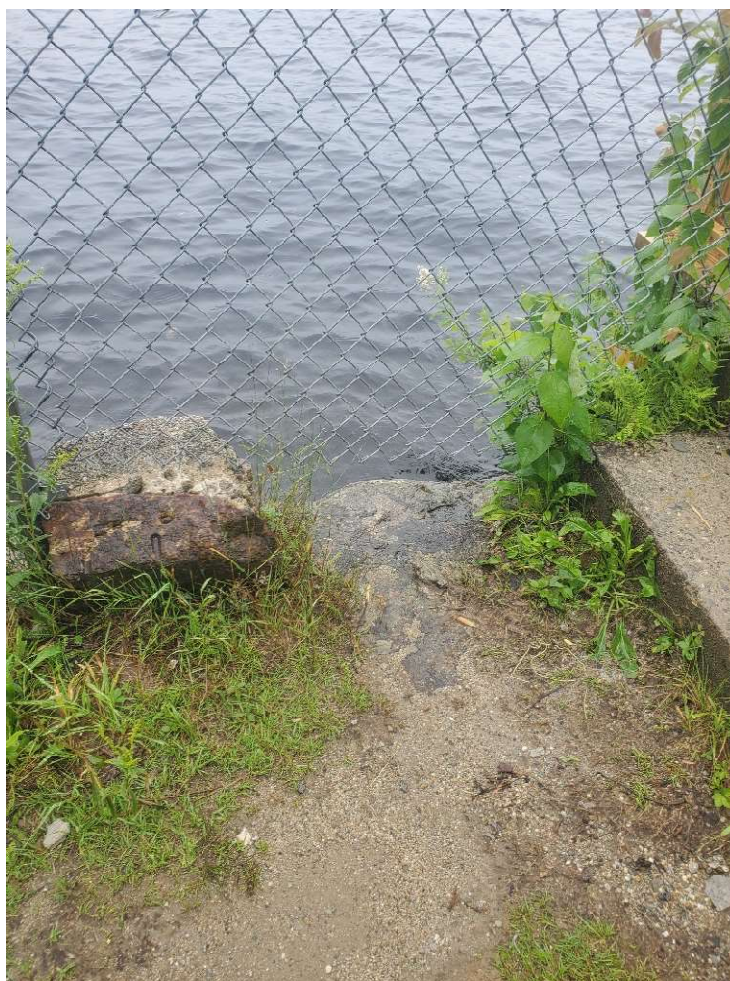
*Photo 10 – High water event July 10, 2023 adjacent to right side of gatehouse (as viewed facing downstream).*

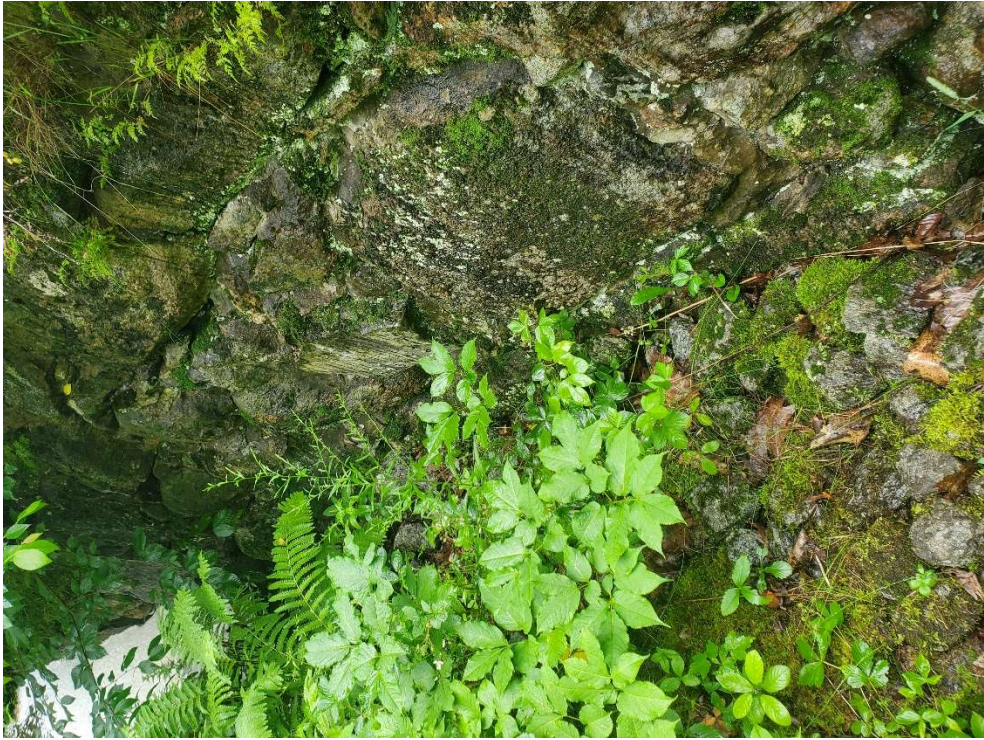
*Photo 11 – No seepage observed on downstream toe of Ashuelot Pond Dam during high water event July 10, 2023*

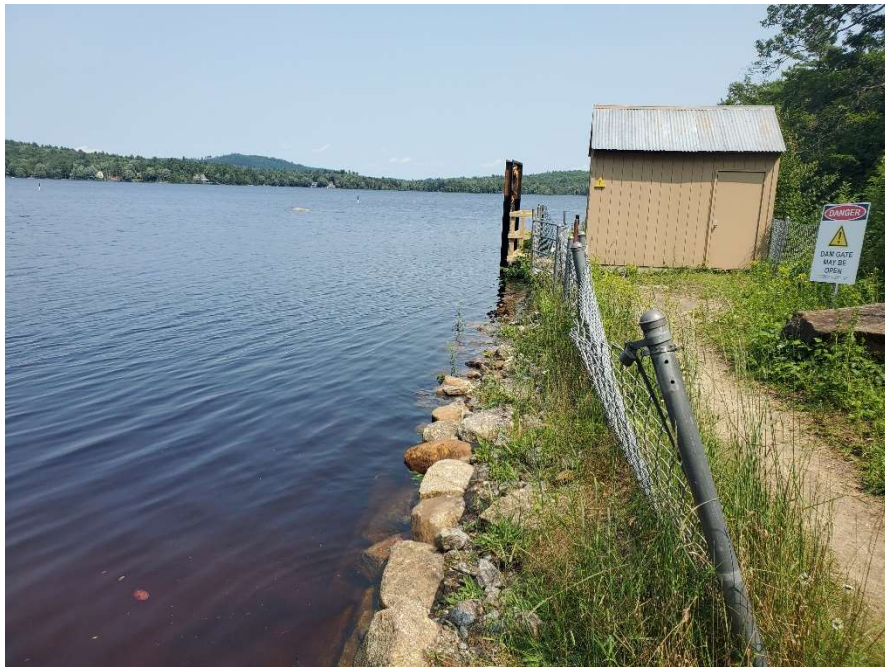
*Photo 12 – High water July 12, 2023, water level has reached the low area to the right of the gatehouse*

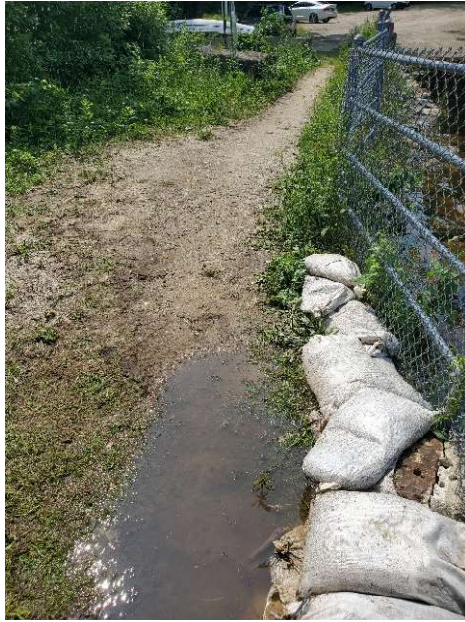
*Photo 13 – Sandbags placed by M&K to prevent overtopping of dam in low area to the right of the gatehouse*

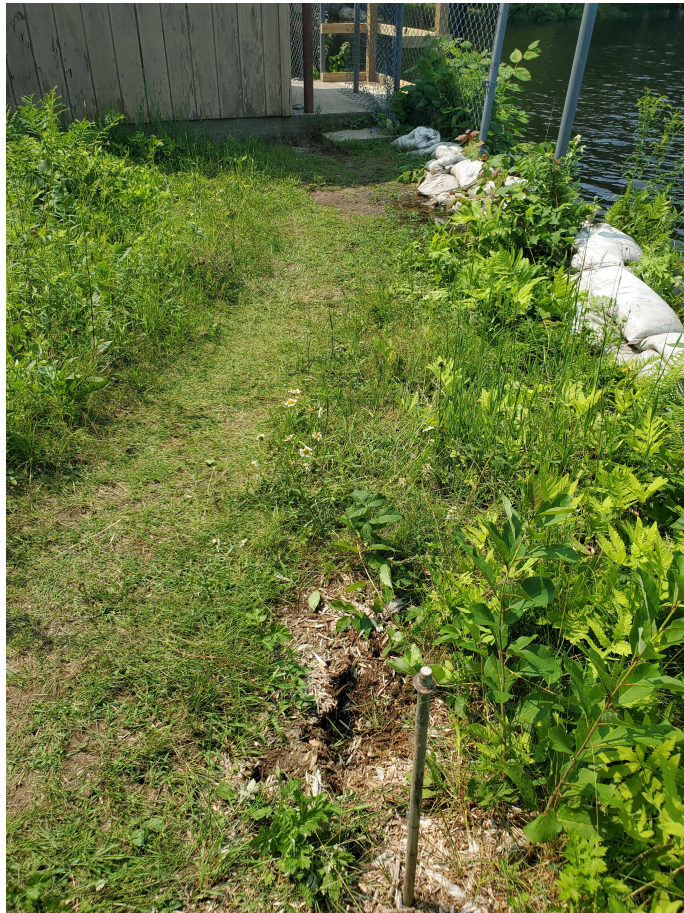
*Photo 14 – Sandbags placed to the left of the gatehouse by M&K to prevent overtopping during high water event July 10, 11 and 12.*
