August 9, 2022  
**Letter of Deficiency**  
DSP #22-003

RE: Ashuelot Pond Dam #D245005, Significant to High, Washington

**D245005 Ashuelot Pond Dam, Washington, Inspected: 07/12/2022**

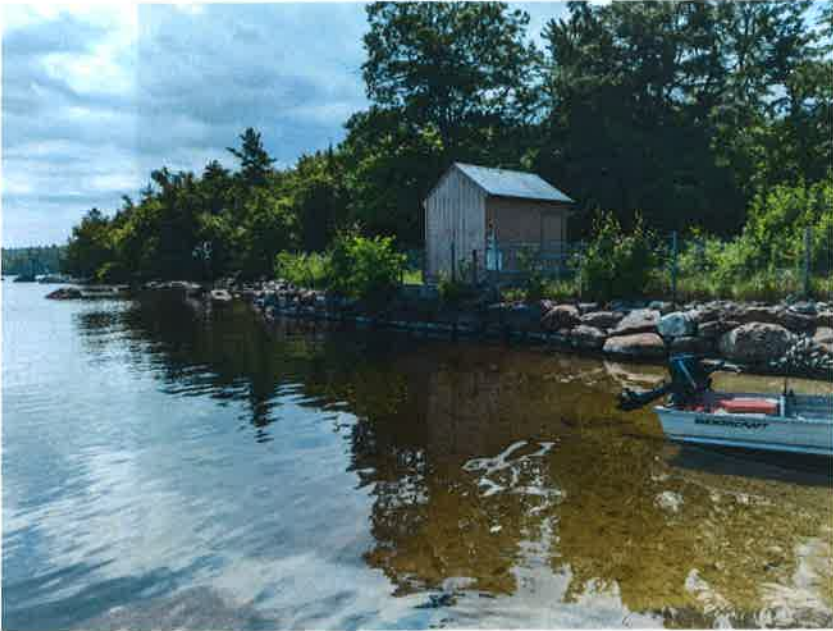
**1.jpg**

- a. Minor brush on the crest (Photos: 1, 8, 11 & 12);
  - b. Minor brush observed on the upstream stone face/slope (Photos: 1 & 8);
  - c. Brush and trees were observed on the downstream stone face and within 15-ft of the downstream face (Photos: 2 - 5);

9. Trees, brush or other unwanted vegetation was noted in the following locations. Such vegetation should be removed and kept at least 15 feet from the entire footprint of the dam and all components of the dam to preserve a buffer for inspection, access and maintenance/repair. After clearing occurs, any disturbed areas should be properly regraded and protected with an appropriate ground cover (grass, riprap stone or other treatments) to prevent erosion of or damage to the dam and its components.

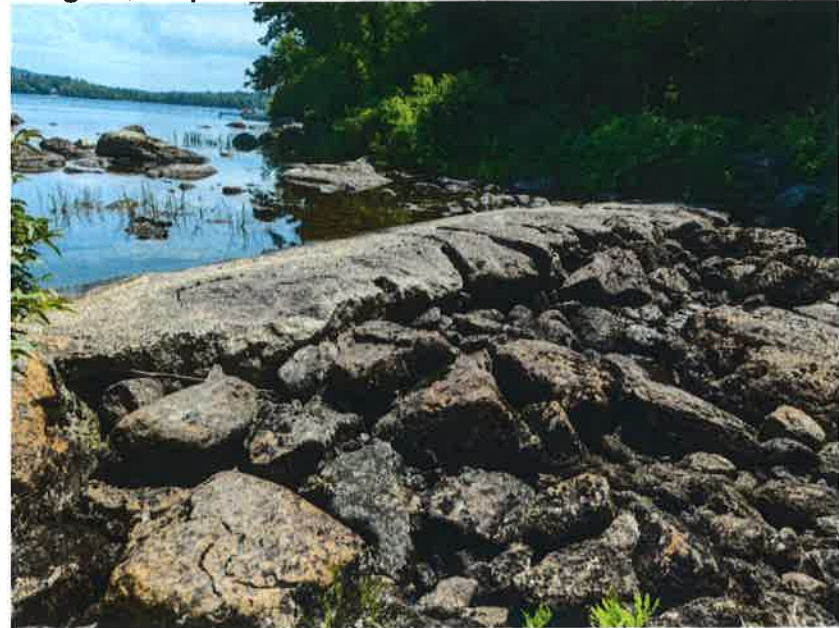
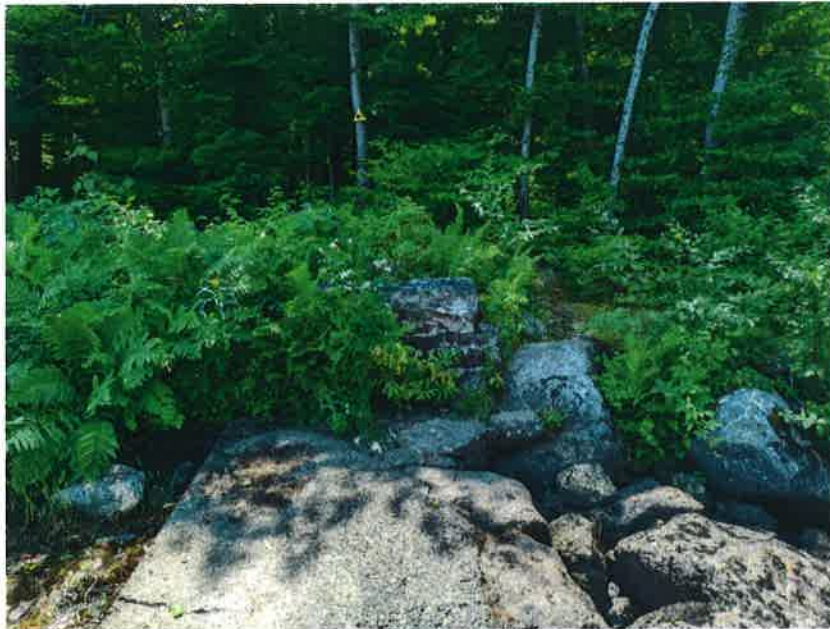
- d. Minor brush within 15-feet of the left and right spillway abutments for the near (West) (Photos: 6 - 8); and
  - e. Brush and trees within 15-feet of the left and right spillway abutments for the far (East) (Photos: 9 - 10)

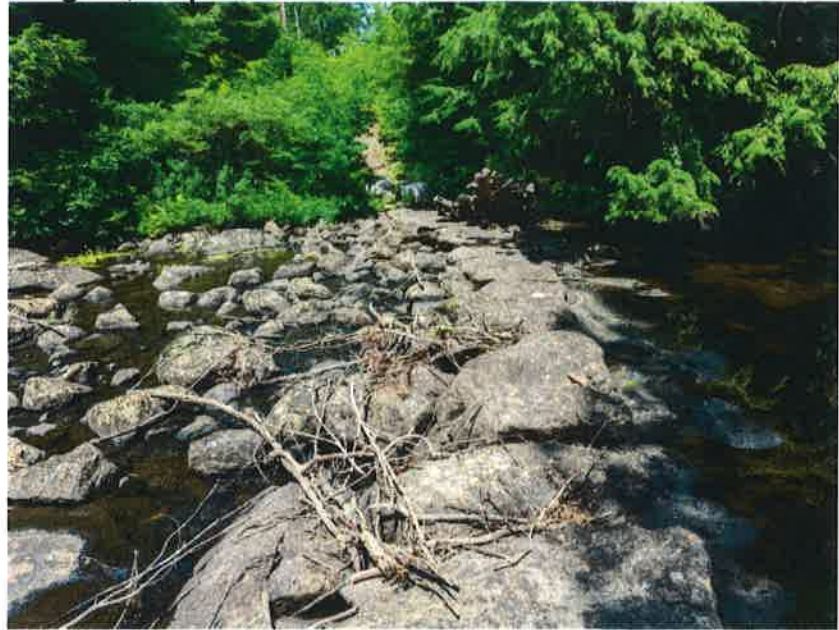
- a. Debris including a large tree stump were observed on the spillway crest (Photos: 9 – 10).
4. Provide copies of the seepage monitoring logs for review.

3. Debris or other material was noted in the following outlet structures and should be removed as soon as possible. Such material will obstruct flow, lessen the dam's ability to function efficiently and increase the risk that the dam may be overtopped – which could lead to failure.
