# Ashuelot Pond Dam Rehabilitation Project

(State ID #D245005)  
Washington, New Hampshire

Conceptual Alternatives Analysis  
September 14, 2026

**Date:** September 14, 2026  
**To:** Ashuelot Pond Dam Village District  
**From:** Charles Johnston, P.E., Evan Joaquin, E.I.  
**Subject:** Ashuelot Pond Dam, Washington, New Hampshire (State ID #D245005)  
Conceptual Alternatives Analysis

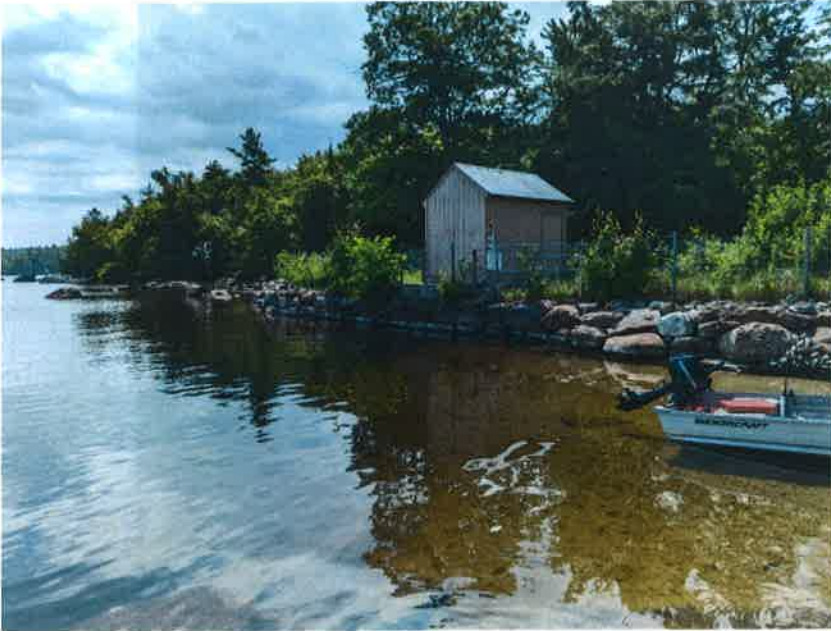
**1.jpg**

- a. Minor brush on the crest (Photos: 1, 8, 11 & 12);
  - b. Minor brush observed on the upstream stone face/slope (Photos: 1 & 8);
  - c. Brush and trees were observed on the downstream stone face and within 15-ft of the downstream face (Photos: 2 - 5);

9. Trees, brush or other unwanted vegetation was noted in the following locations. Such vegetation should be removed and kept at least 15 feet from the entire footprint of the dam and all components of the dam to preserve a buffer for inspection, access and maintenance/repair. After clearing occurs, any disturbed areas should be properly regraded and protected with an appropriate ground cover (grass, riprap stone or other treatments) to prevent erosion of or damage to the dam and its components.

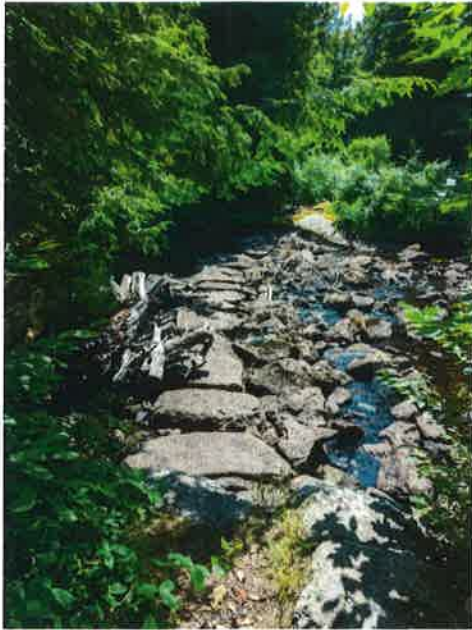
9.jpg

3. Debris or other material was noted in the following outlet structures and should be removed as soon as possible. Such material will obstruct flow, lessen the dam's ability to function efficiently and increase the risk that the dam may be overtopped – which could lead to failure.

- a. Debris including a large tree stump were observed on the spillway crest (Photos: 9 – 10).
4. Provide copies of the seepage monitoring logs for review.
