January 28, 2024

SUBJECT: D245005 Ashuelot Pond Dam; Gate House Structural Evaluation
High Hazard Dam; Washington, New Hampshire

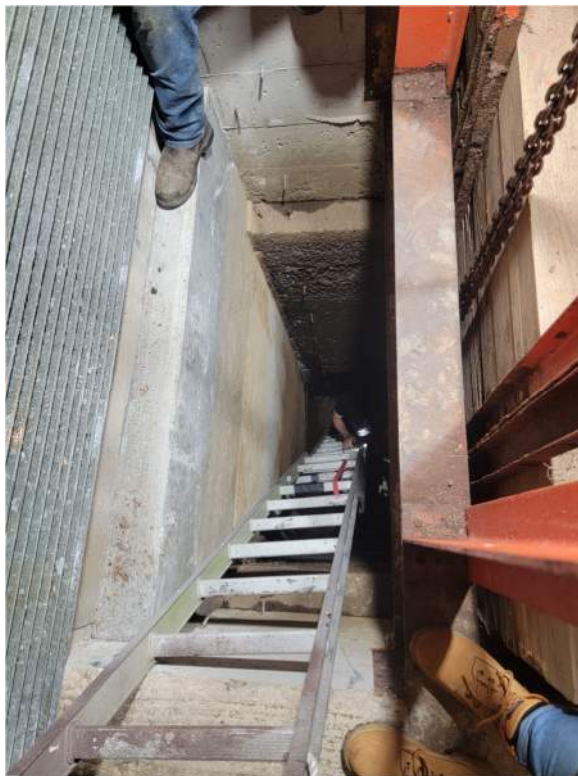
This wall section has recently been renovated by a reinforced concrete overlay of the existing dry-laid stone masonry. The concrete overlay ranges in thickness from 6” to 8” and extends to an elevation above the dry-laid inlet lintel stone, approximately 12-feet above the concrete invert of the gate house water pit inlet invert. There is a mass of concrete over-pour at the gate house invert from recent repairs that needs to be removed to restore a consistent invert elevation.

Photo 1 – Ashuelot Pond Dam Gate House – interior face of upstream gate house water pit (Wall A from Figure 1)

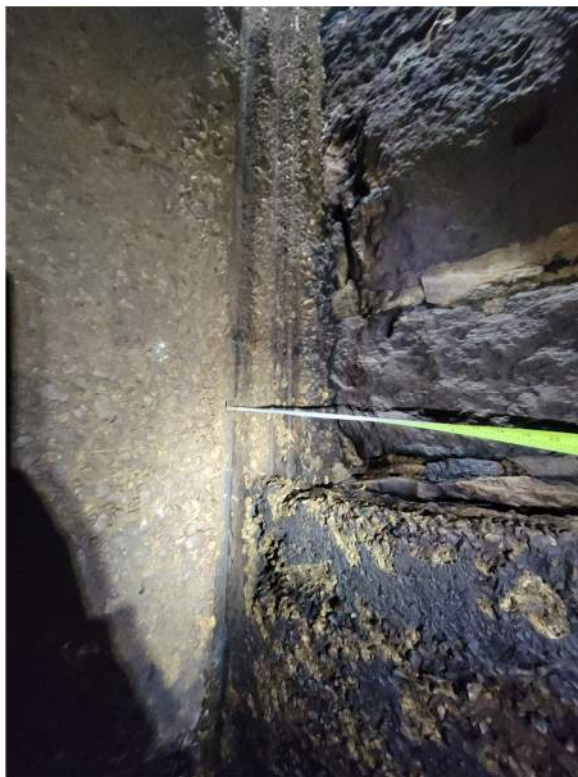
Similar to wall sections B & F, these wall sections appear to be overlays over the original dry-laid stone masonry of the gate house water pit. The coarse aggregate of the concrete is exposed where erosion of the fine concrete particles has occurred. There were no observed notable cracks or discontinuities in the wall sections C & E. It should be noted on the downstream end of these wall sections, what appears to be an approximately 5" facing gate slots were formed into the concrete. These appear to have been gate slots for the historical outlet from the gate house water pit. The total length of wall sections C & E is approximately 3' including the 5" gate slots. See attached photo pages.

There was no observed discontinuity between the joints of the stone masonry, and no observed indications of stones being dislodged or displaced by structural stress or strain. Any crack in previously placed pointing appears to be the result of aging masonry and not the result of movement of the dry-laid stone. See photo pages.

Photo 2 – Ashuelot Pond Dam Gate House – downstream left corner at former stoplog bay (elevation view facing downstream at corner of walls C & D)

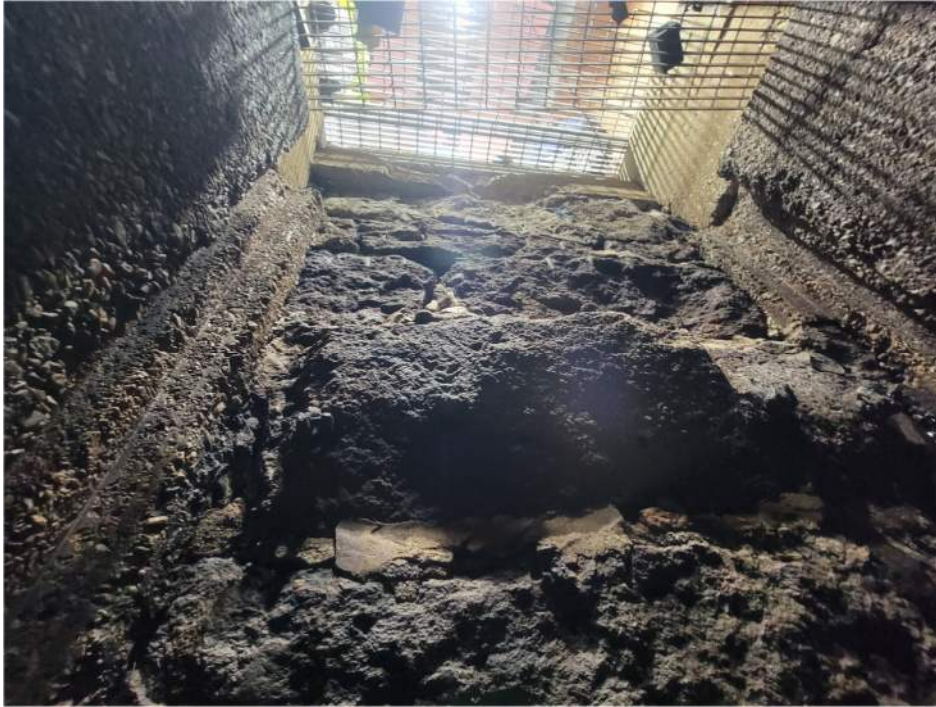
The downstream wall of the gate house water pit appears to be dry-laid stone masonry that has been repointed at various times. The face of the downstream wall has a variable distance from the existing stoplog stanchion gate, however in general is approximately 3' from the downstream face of the existing gate.

Photo 3 – Ashuelot Pond Dam Gate House – interior face of downstream gate house water pit (elevation view of Wall D facing downstream)

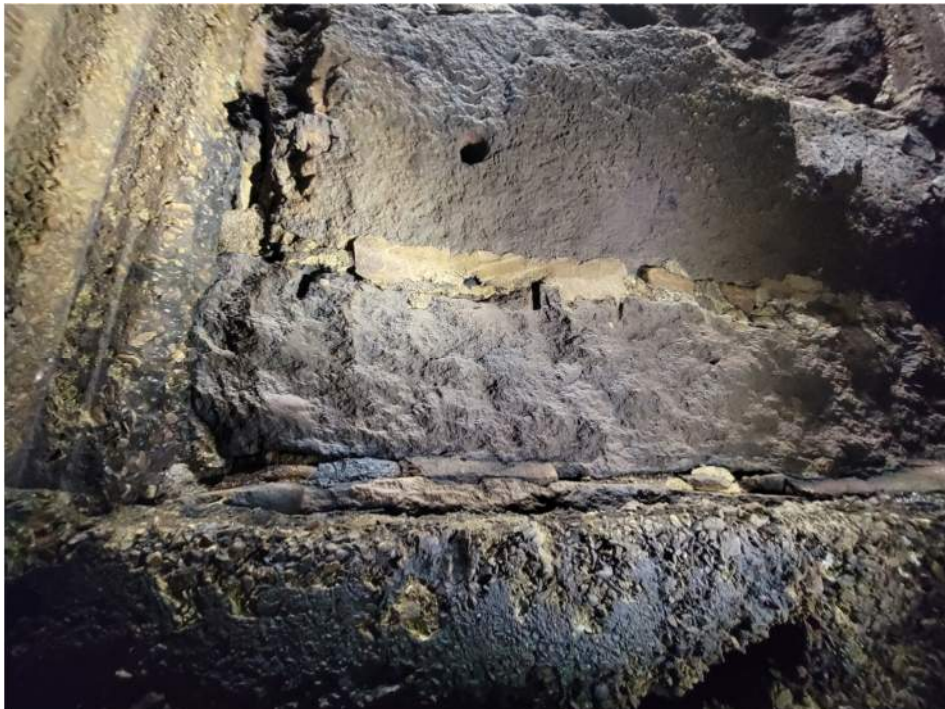
Photo 4 – Ashuelot Pond Dam Gate House – interior face of downstream gate house water pit above outlet (elevation view of upstream face of Wall D facing downstream)

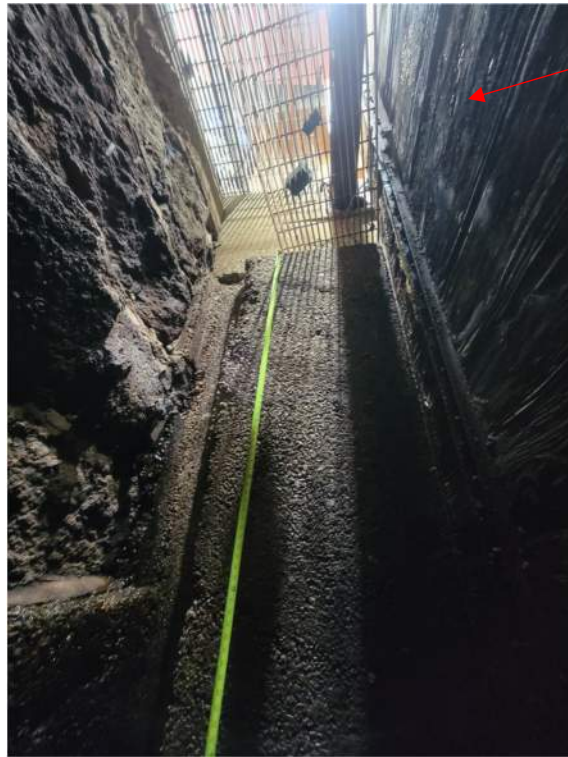
Photo 5 – Ashuelot Pond Dam Gate House – face of right gate house water pit wall downstream of existing gate (Wall E)

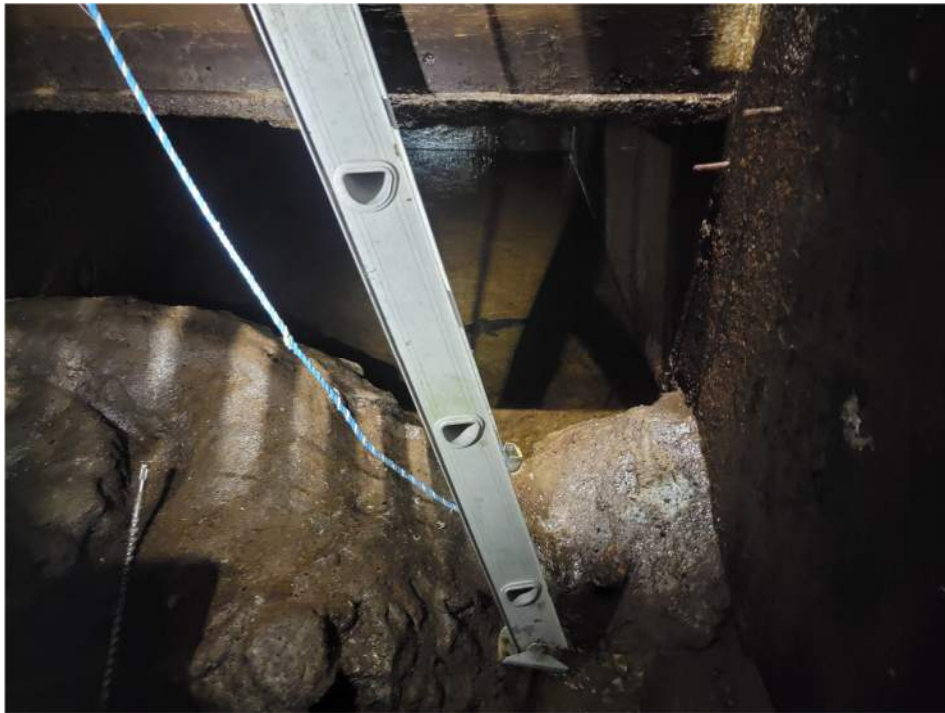
Photo 6 – Ashuelot Pond Dam Gate House – concrete over-pour at downstream end of gate house inlet (to be removed) (Base of Wall A)

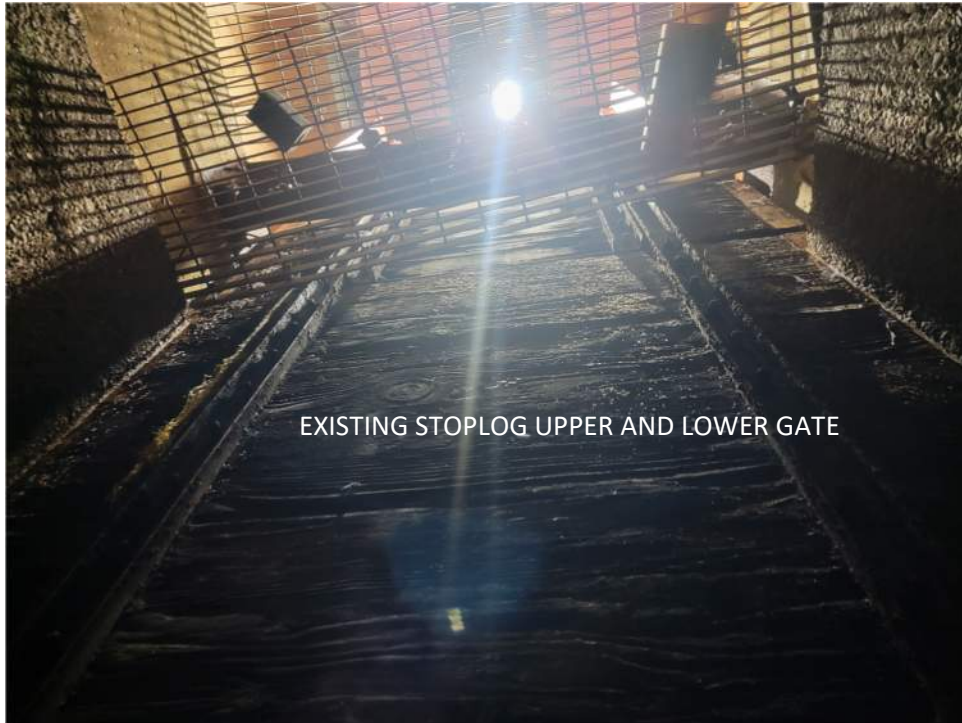
Photo 7 – Ashuelot Pond Dam Gate House – downstream face of existing gate

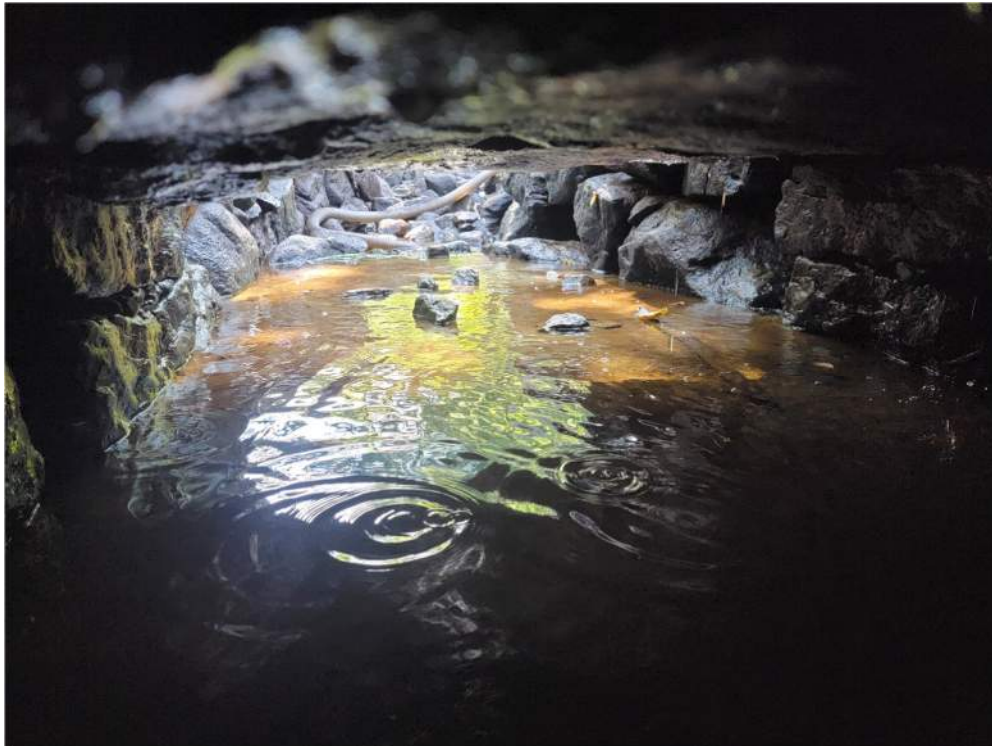
Photo 8 – Ashuelot Pond Dam Gate House – outlet channel of gate house (base of wall D)

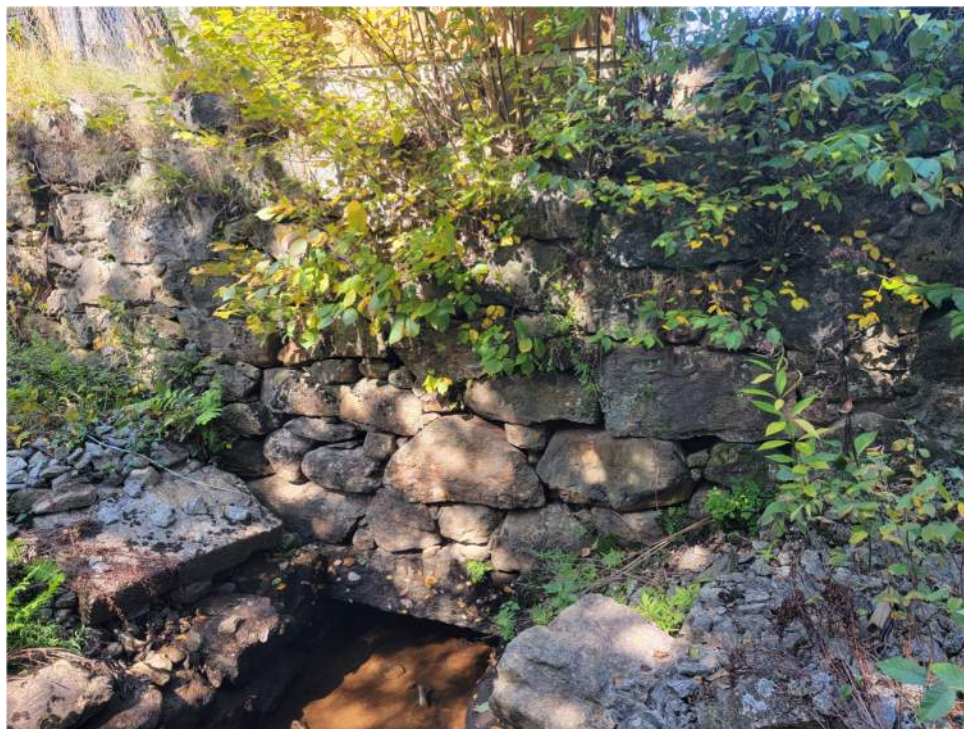
Photo 9 – Ashuelot Pond Dam Gate House – downstream exterior face of gate house and dam at outlet

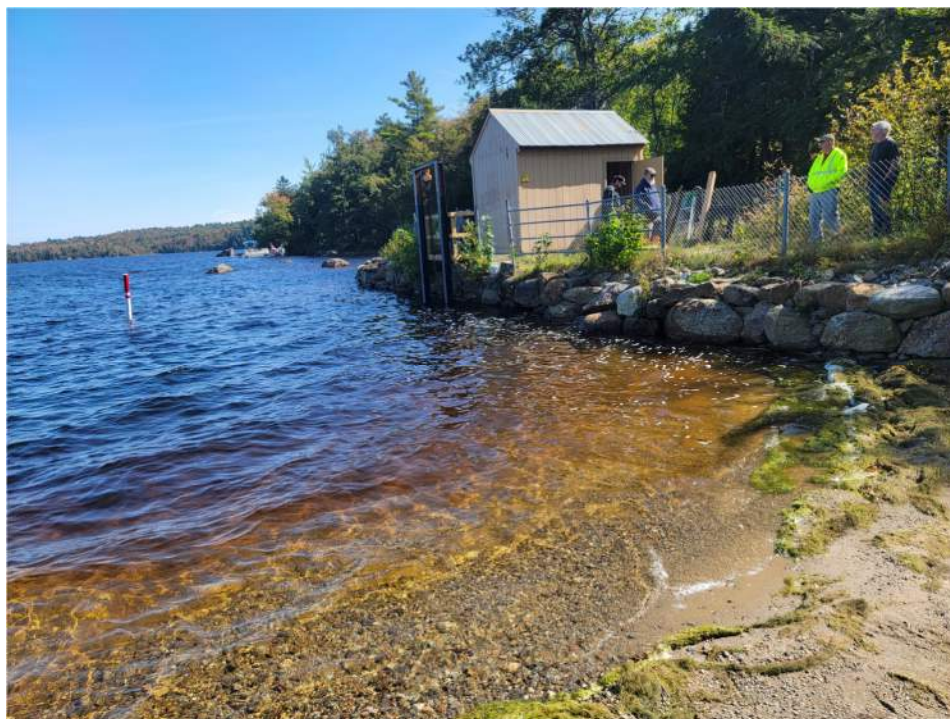
Photo 10 – Ashuelot Pond Dam – upstream face of dam
